Investigation of the impact damage due to high-energy objects on the wreckage of flight MH17

Customer
Dutch Safety Board

NLR-CR-2015-155-PT-1 - September 2015

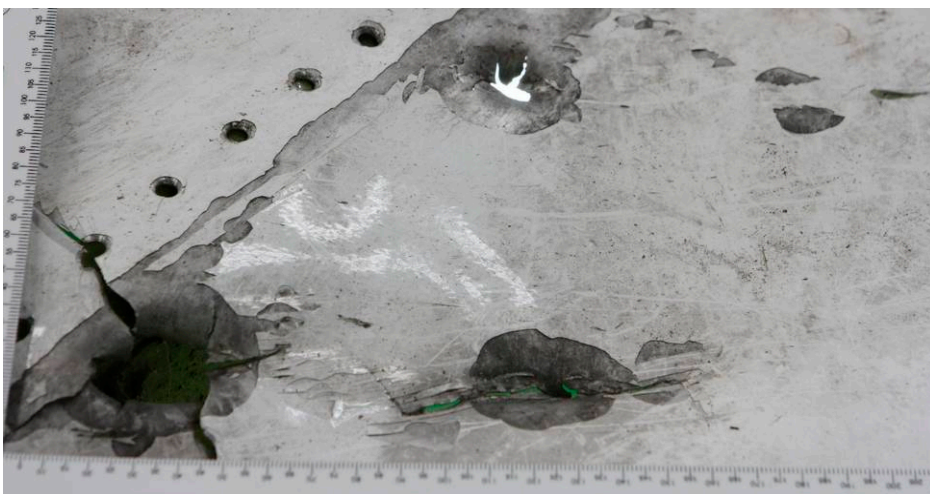
1. Piercing damage. In piercing damage the high-energy object penetrates the plate by pushing the plate material aside. The high-energy object tears through the plate during penetration, and a crown-shaped protrusion surrounded by radial cracks is formed on the exit side of the plate.

Figure 3: Piercing damage (Source: DSB)

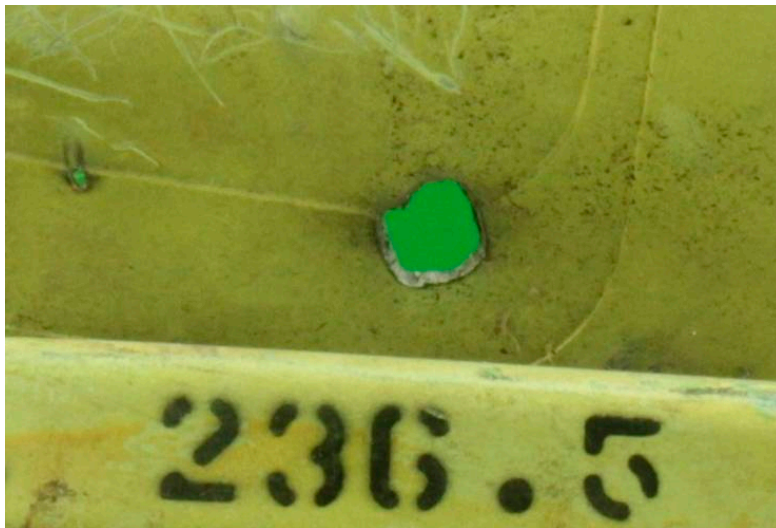
2. Plugging damage. In plugging damage the high-energy object impacting the plate produces a relatively clean hole by shearing out a portion of the plate known as a plug.

Figure 4: Plugging damage (Source: DSB)

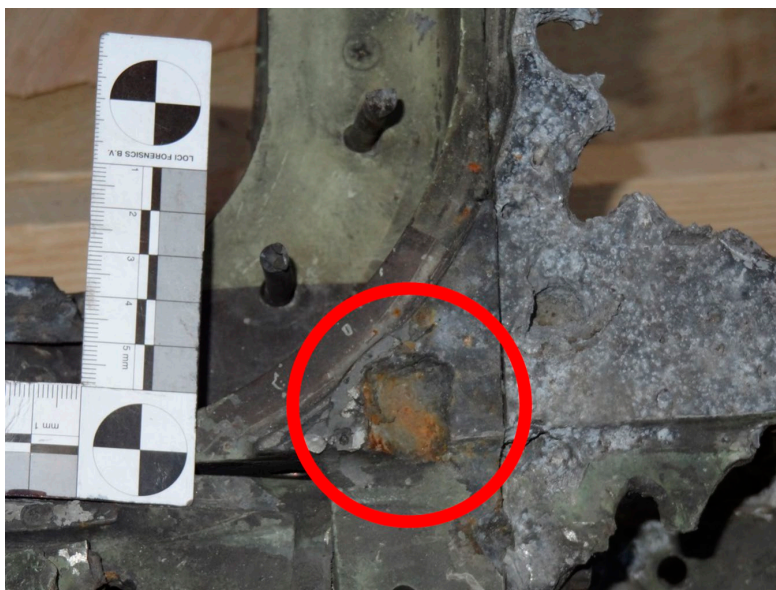
3. Non-penetrating damage. Where relatively strong, thick and reinforced parts of the airframe structure were present; a number of high-energy objects did not have enough energy to fully penetrate the structure and produced non-penetrating damage.

Figure 5: Non-penetrating damage

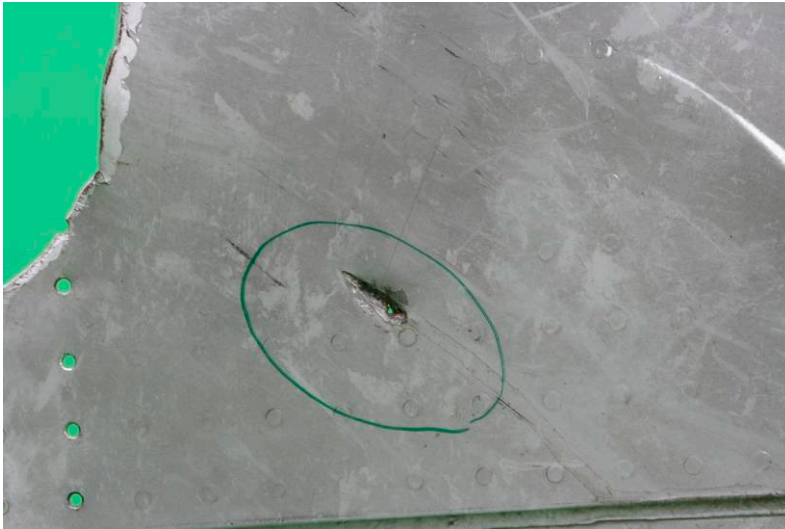
4. Ricochet damage. When the angle of impact on a plate is shallow, the object will not be able to fully penetrate the structure and ricochets off the plate leaving non-penetrating ricochet damage.

Figure 6: Ricochet damage (Source: DSB)

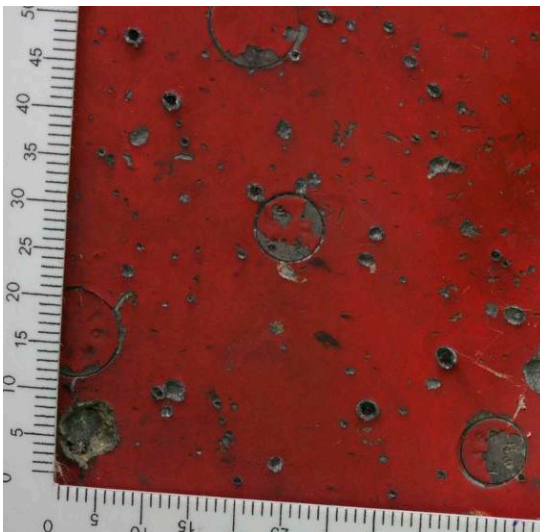
Besides the direct impact damage of high-energy objects found on the aircraft, pitting was also observed on some parts of the wreckage of the cockpit [3]. Pitting is a phenomenon that occurs on metal surfaces that are in proximity to detonating explosives and indicates the occurrence of an explosive event nearby (Figure 7).

Figure 7: Pitting (Source: DSB)

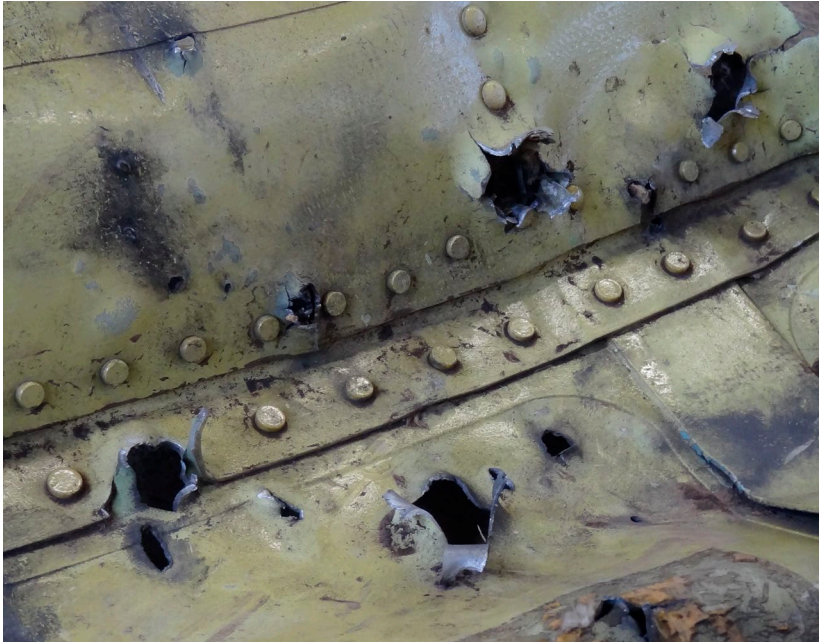
The observed impact damage by high-energy objects originates from outside the aircraft. Both piercing and plugging damage observed are identified as entry damage bending the plate material inwards (Figure 8). The non-penetrating damage as well as the ricochet damage also clearly originates from outside the aircraft.

Figure 8: Plate material bent inwards. Looking at the inside of the structure

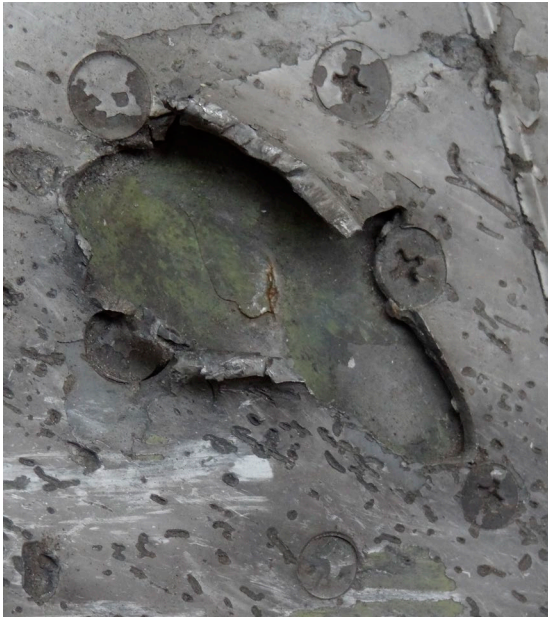
At certain parts of the structure, where multiple layers of plate material are riveted together, some high-energy objects impacted the structure at a shallow angle, penetrating the first outer plate but ricocheting back from the second plate and exiting through the outer plate. This creates the outer layer penetration damage as seen in Figure 9.

Figure 9: Outer layer penetration

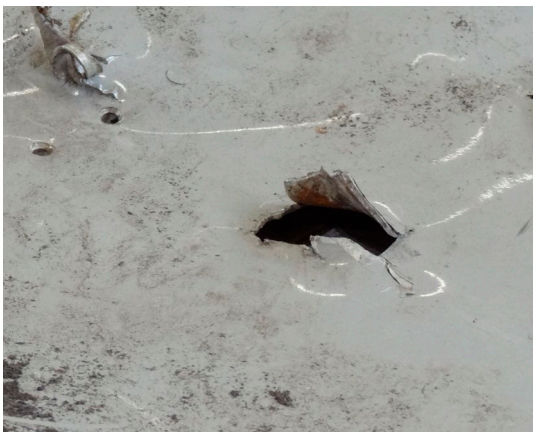
Exit damage is observed on the wreckage of the lower right-hand side of the cockpit (Figure 10). This is an indication of a direction of impact from the upper left-hand side of the cockpit towards the lower right-hand side of the cockpit.

Figure 10: Exit damage on lower right-hand side of the cockpit

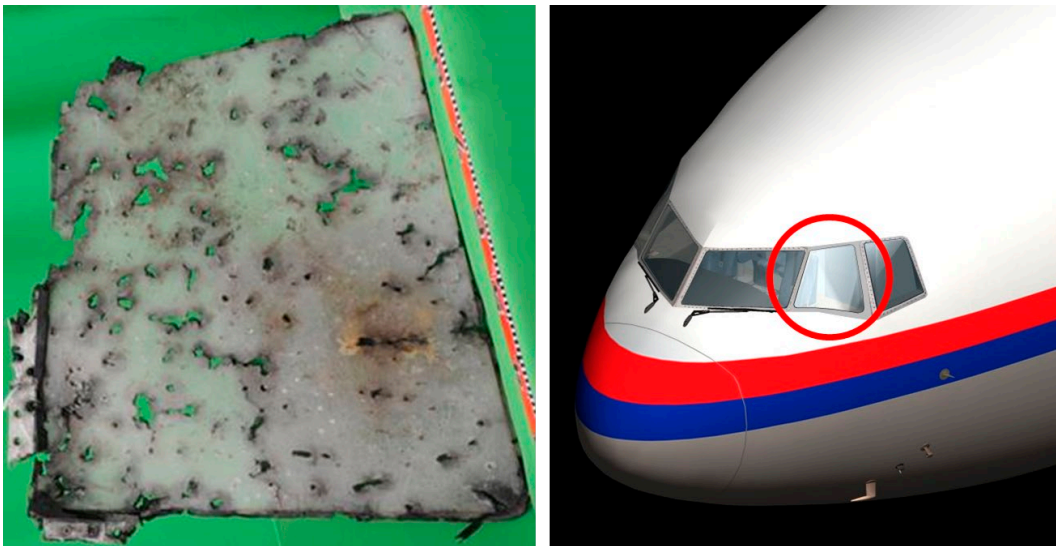
The total number of hits of all types of impact damage on the initially available wreckage was counted and found to be 304. After this, additional parts of the wreckage became available. Accounting for the additional hits on these parts the total number of impacts is assessed to be more than 350. Extrapolating the number of hits on the affected area of the fuselage and accounting for the structure that was not available gives an estimate of the total number of hits of high-energy objects of over 800. The highest density of hits was on the middle window on the captain's left-hand side of the cockpit (window number 2). The cockpit windows are made of multiple layers of glass and plastic and one of the layers of this window was recovered. See Figure 11 for this window layer and its location in the cockpit. The density in this area is calculated to be around 250 hits per square meter.

Figure 11: Left cockpit window 2 layer and location (Source: DSB)

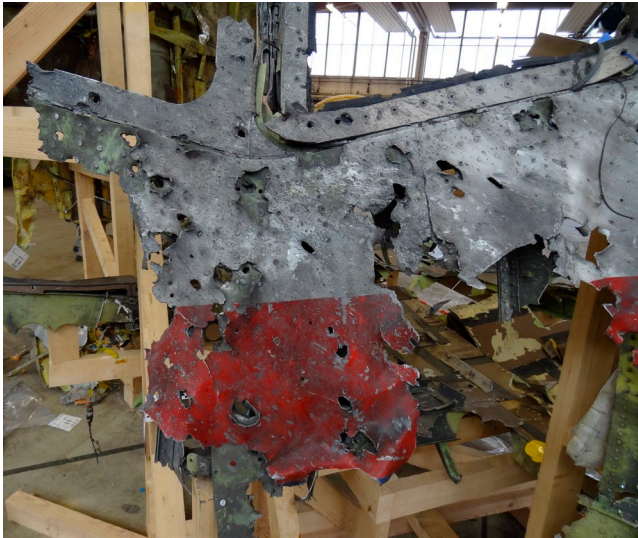
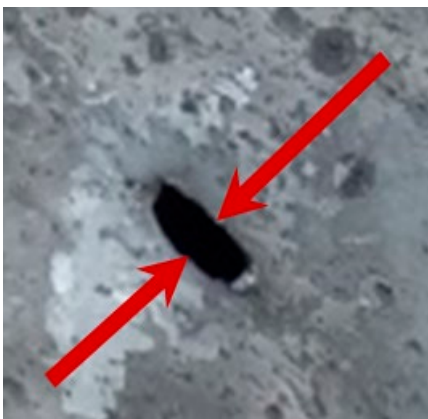
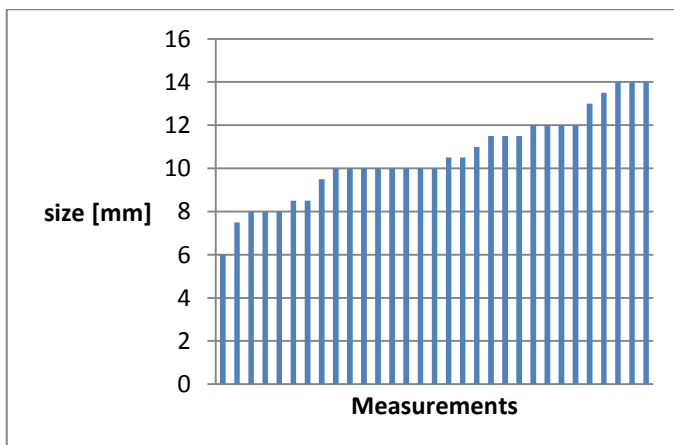
On the piece of cockpit skin with the highest number of penetrations, the size of the holes caused by these penetrations was measured (Figure 12). Only the damage that was assessed to be the result of single objects fully penetrating the plate was taken into account. Of each hole the dimension perpendicular to the impact direction was measured (Figure 13). Only this dimension gives an indication of the size of the object that caused the damage. The larger dimension, parallel to the projection of the impact direction on the plate, is the result of the speed and the angle at which the object impacts the plate. As can be seen in Figure 14, the size was found to range from 6 mm to 14 mm.

Figure 12: Piece of wreckage used for size of penetration measurement

Figure 13: Measurement of penetration damage

Figure 14: Size of penetration damage

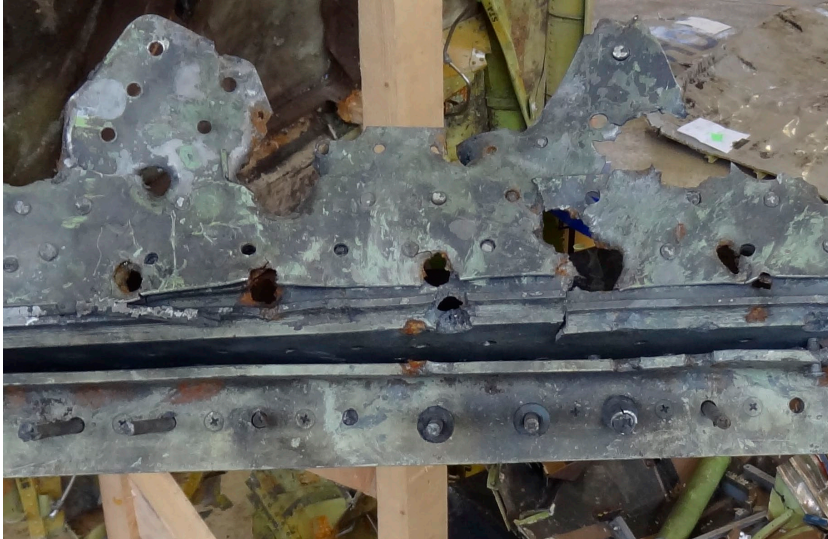
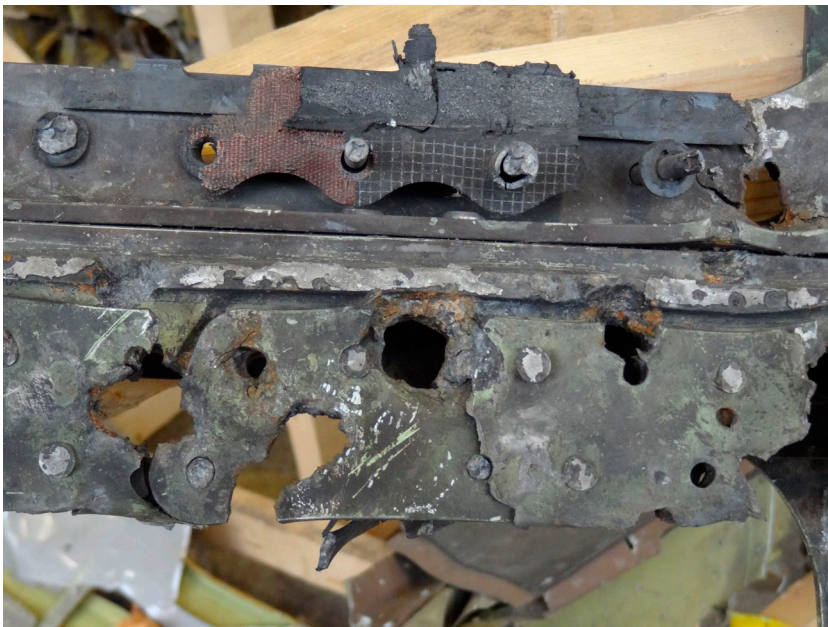
On several parts of the wreckage a regularity of hits was observed. Figure 15 and Figure 16 are examples of hits at regular intervals. This regularity of hits is an indication that the damage was caused by a warhead with preformed, separate fragments. See section 6.10 for a more in depth discussion of this subject.

Figure 15: Regularity of hits on upper cockpit window frame

Figure 16: Regularity of hits on lower cockpit window frame

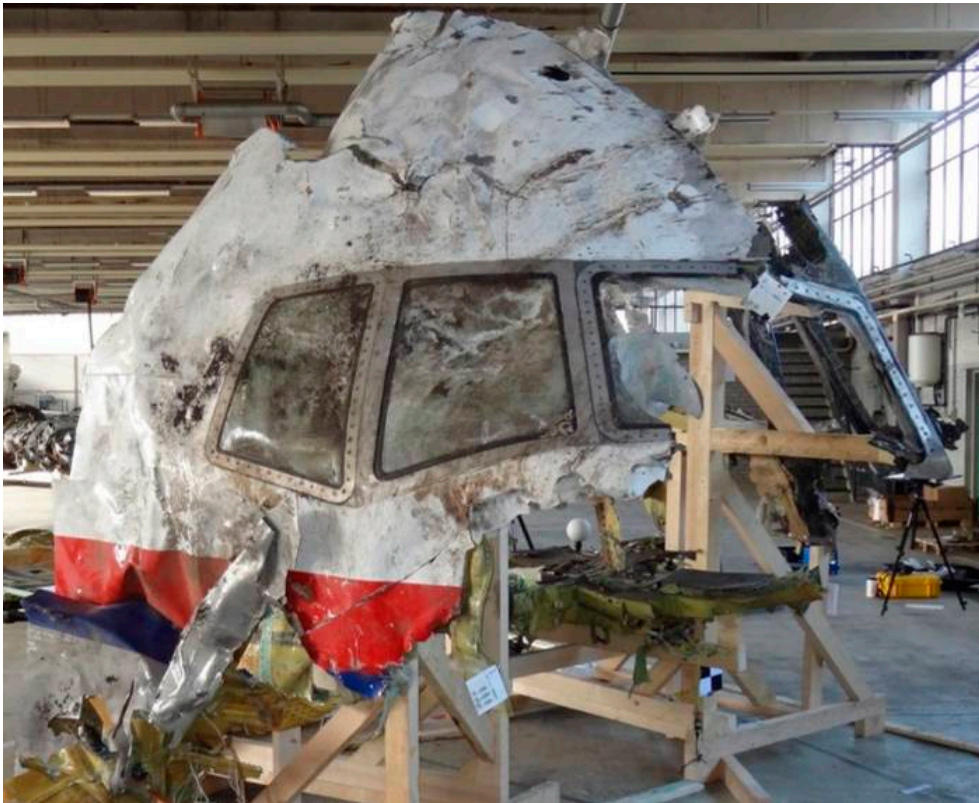
The main location of the impact damage of high-energy objects is on the left-hand and upper side of the cockpit. The right-hand side of the cockpit shows no high-energy object impact damage. In particular the two co-pilot's windows on the right-hand side show no penetration damage as can be seen in Figure 17.

Figure 17: Right-hand side of cockpit

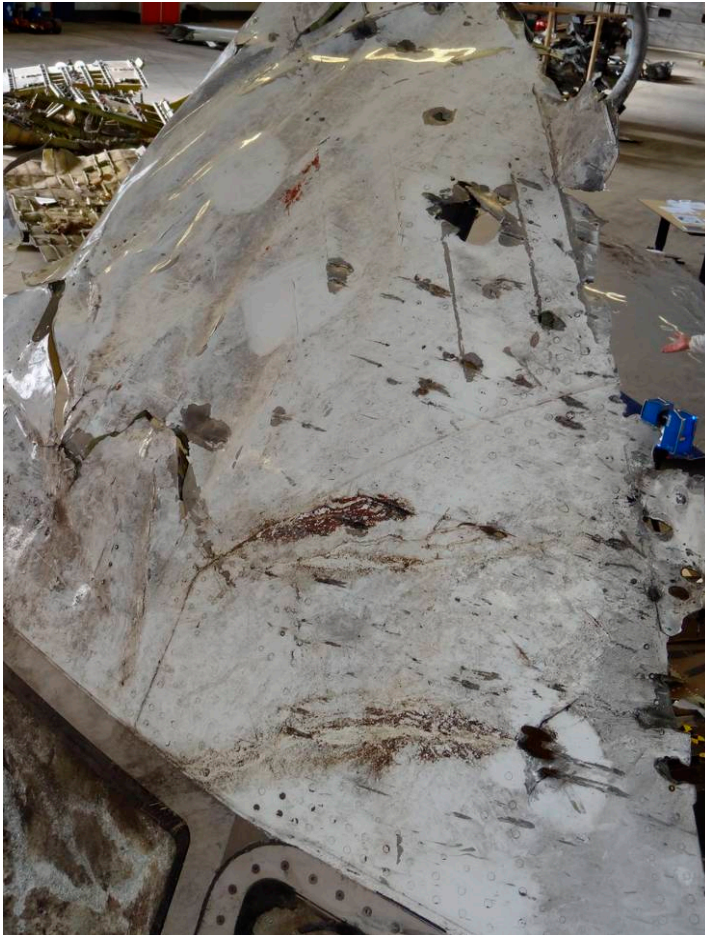
On the top and right-hand side of the cockpit the damage boundary is indicated by the ricochet impacts on the cockpit roof as shown in Figure 19. To the right (starboard side) of this area no impact damage is present.

Figure 19: Right-hand side cockpit roof (looking nose to tail)

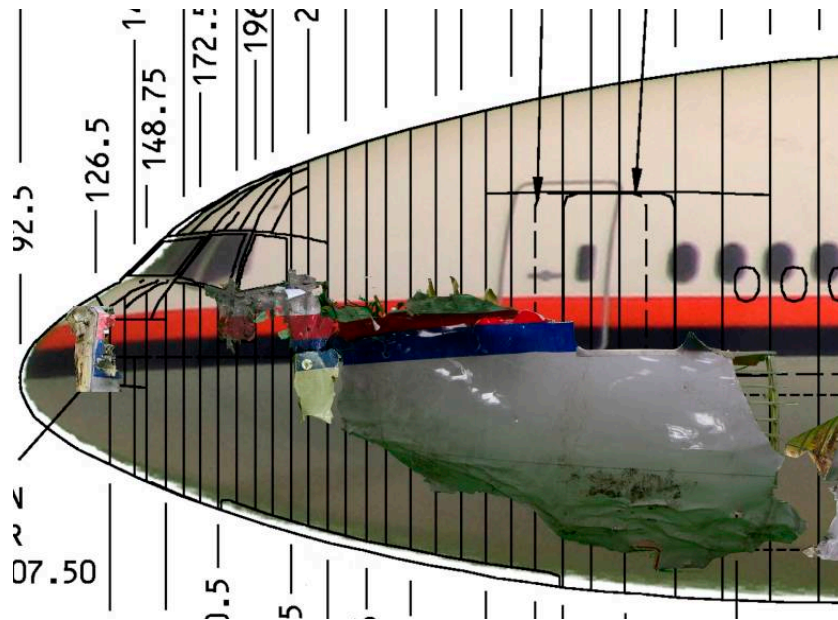
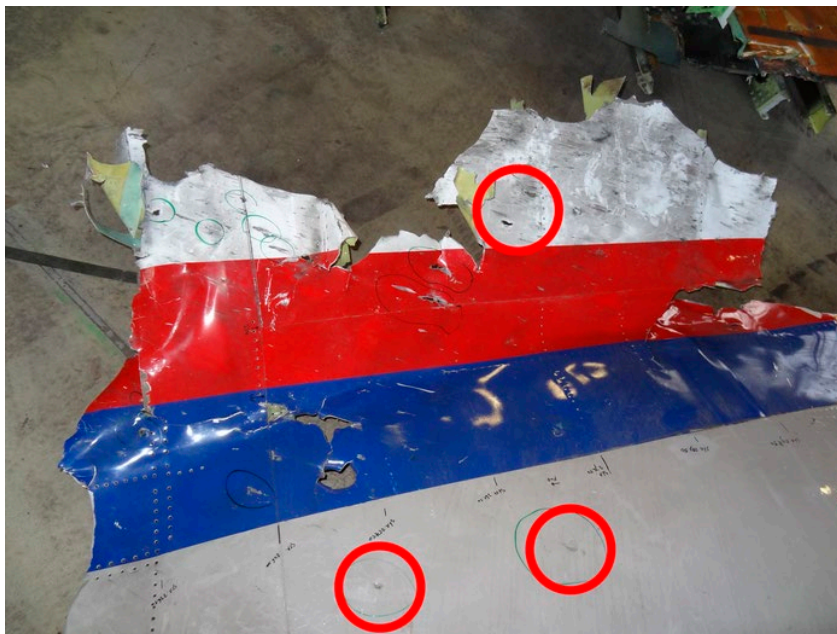
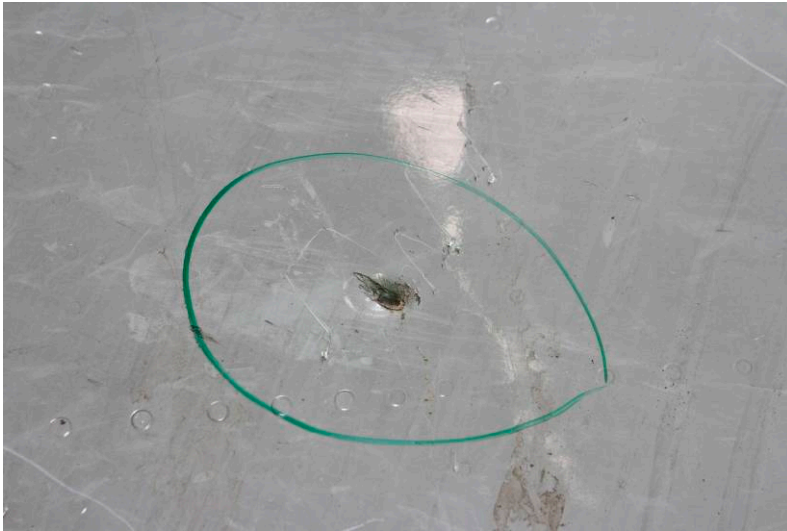
The rearmost impact damage boundary is found on the left-hand side in front of the left-hand forward passenger door. Figure 20 through Figure 22 show the most rearward high-energy object ricochets.

Figure 20: Left-hand side panel location (Source: DSB)

Figure 21: Left-hand side panel with ricochet damage

Figure 22: Detail of left-hand side panel ricochet damage

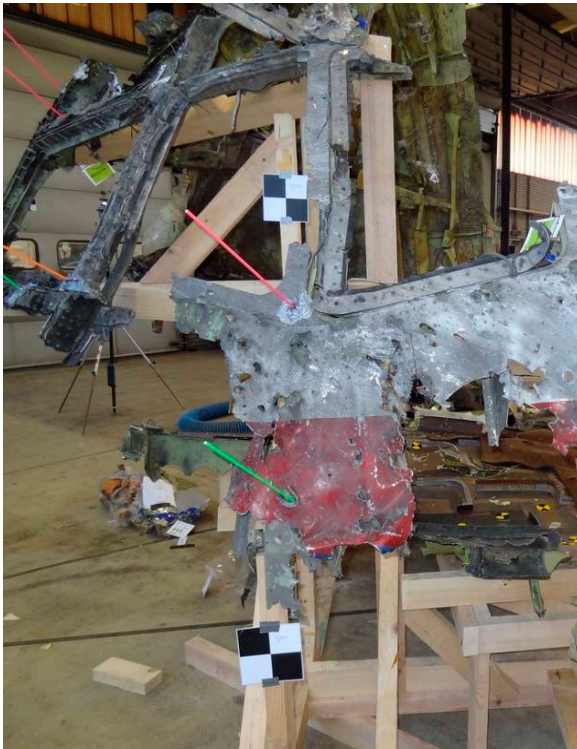
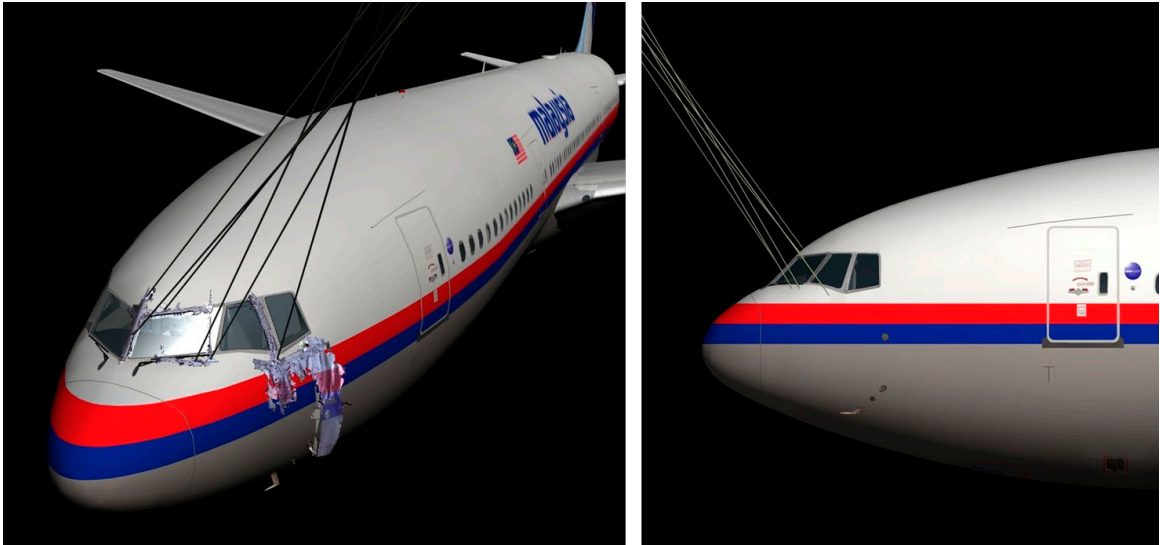
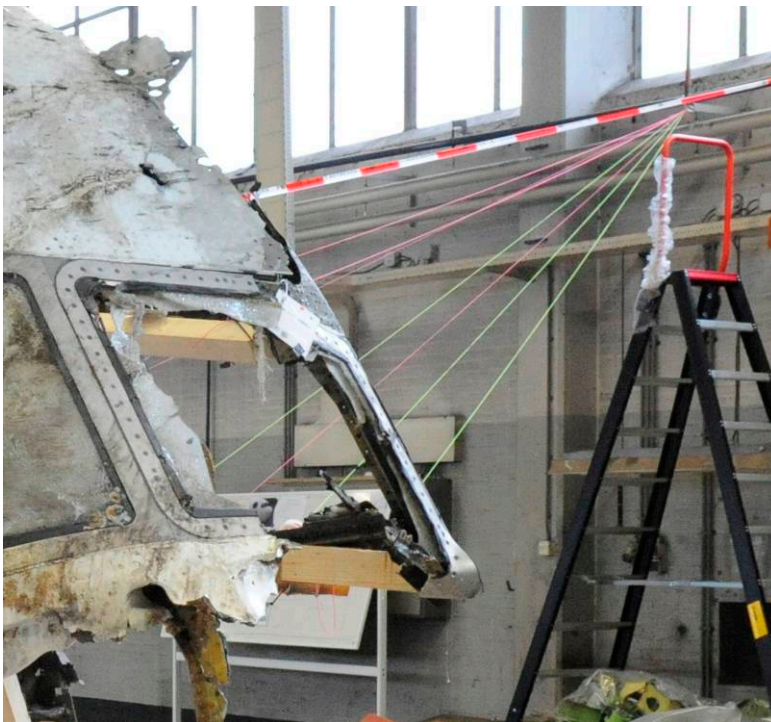
To determine the high-energy objects trajectory, the direction of the impact damage was analysed on several parts of the cockpit area. Using fibreglass rods and 3D-scans of the structure, the direction of high-energy objects penetrating multiple layers of material was determined. The results of this analysis can be found in Figure 23 and Figure 24. Also the forensic technique of stringing was used to analyse the general direction of the impact damage on the actual wreckage as can be seen in Figure 25. The back traced trajectories of the penetrating damage converge to a general area to the left of, and above, the cockpit.

Figure 23: High-energy objects impact direction

Figure 24: High-energy objects impact direction origin in 3D-scan

Figure 25: Stringing of high-energy objects impacts to determine general location of origin (Source: DSB)

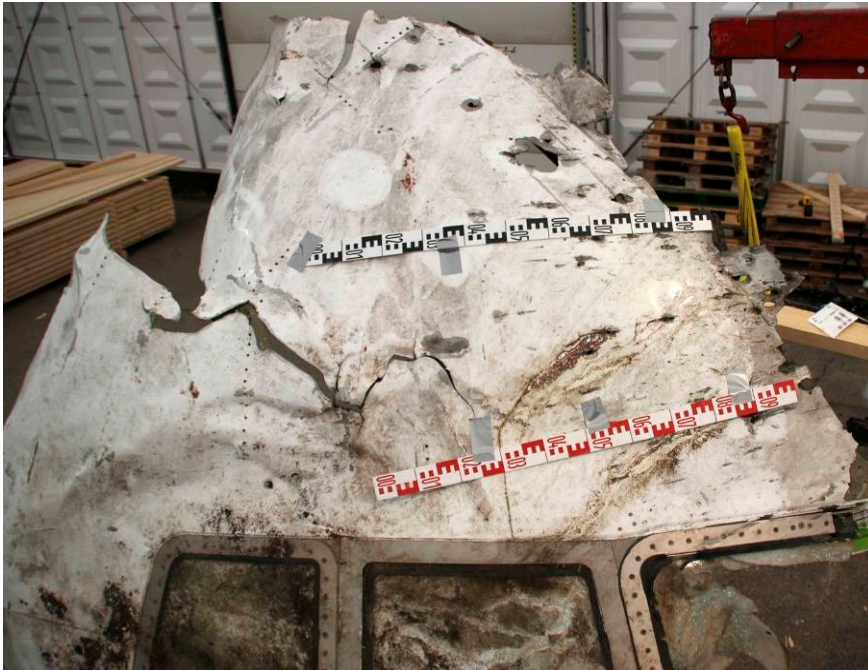
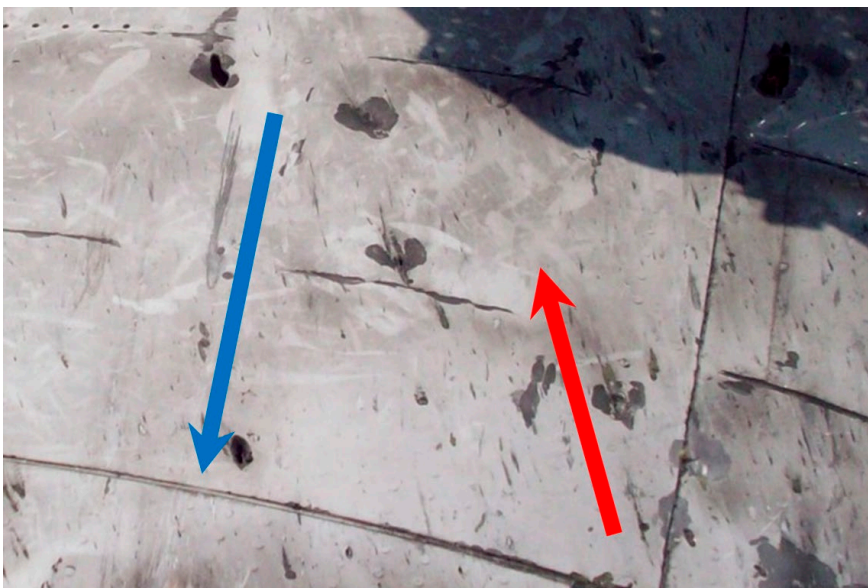
For the non-penetrating ricochet and grazing hits the angle relative to the structure was measured to give a direction in the plane of the aircraft skin. This was done for the cockpit roof (Figure 26) and the left-hand side of the cockpit.

Figure 26: Rulers showing local direction of ricochet damage on cockpit roof

Because a piece of cockpit roof was not yet available to the Dutch Safety Board at the time of writing, the angle of ricochet damage on this piece was determined using photographs. This piece was located on the top of the cockpit, more to the rear of the aircraft. Figure 27 shows a detail of this cockpit roof. The flight direction is indicated with a blue arrow and the ricochet damage direction with a red arrow.

Figure 27: Direction of ricochet damage (red) on cockpit roof. Blue arrow indicates flight direction (Source: DSB)

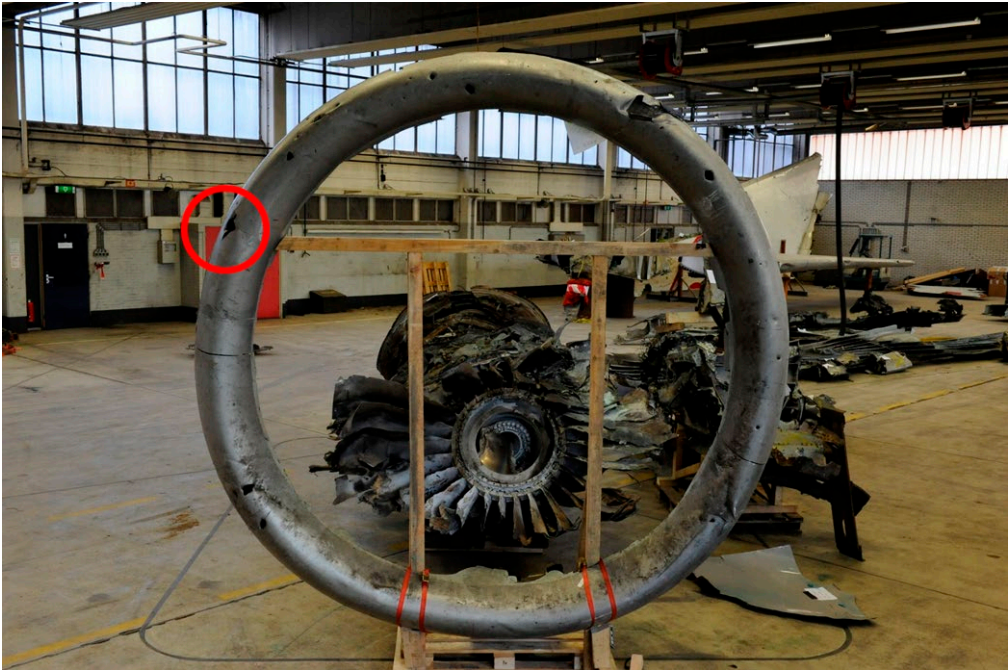
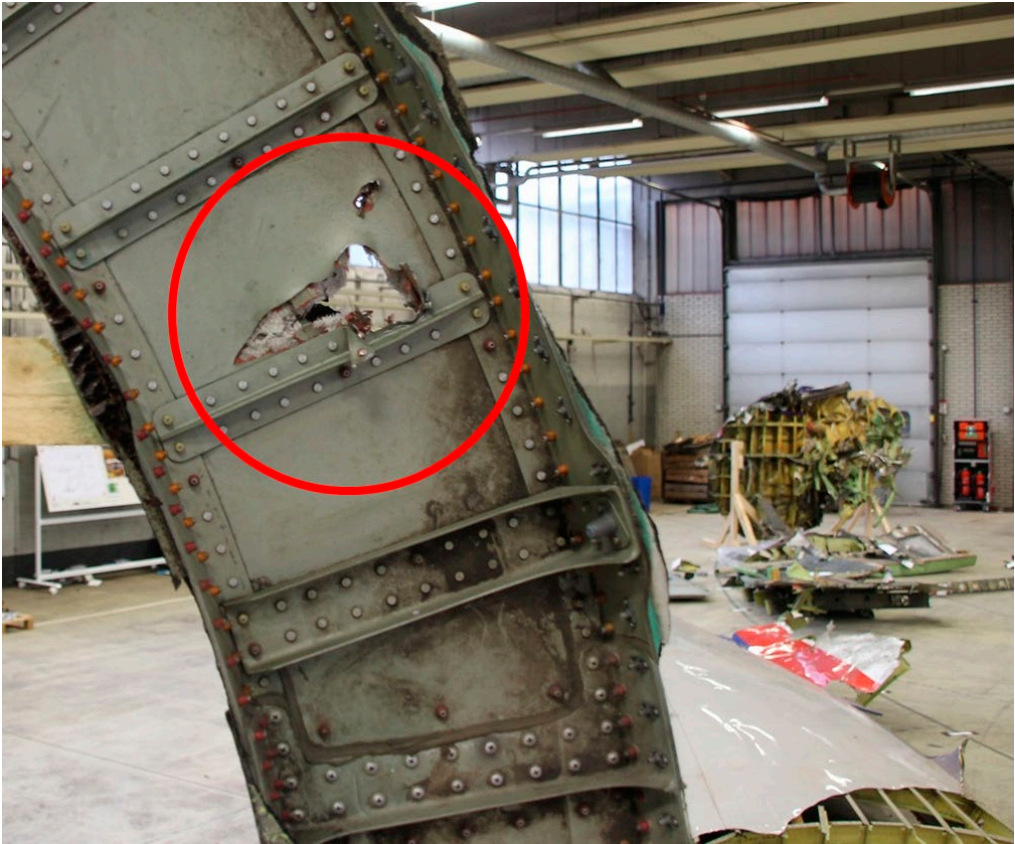
Besides the main high-energy object impact damage on the cockpit there are two further areas where impact damage is observed: the left engine cowling ring and the left wingtip. The left engine cowling ring is a hollow structure consisting of an aerodynamically shaped curved front and a flat plate rear. A number of objects have penetrated both parts of this structure from the front to the rear and from this a trajectory direction can be derived. In Figure 28 and Figure 29 the front and rear plate penetrations caused by the same object has been indicated. In Figure 29 it is possible to look through both holes to obtain the direction of the line of sight through these holes. The engine cowling ring has been placed at the correct location with respect to the cockpit, of which the back side of the front bulkhead is visible on the right side of Figure 29. The observed penetrations show a general object trajectory direction originating from an area to the left of, and above, the cockpit. The size of the damage caused by objects that penetrated both front and rear plate is significantly larger than the impact damage found on the wreckage of the cockpit. The size of all penetrations of the front of the ring was measured and found to range from 1 to 200 mm. Only 5 of the 47 penetrations were in the same 6-14 mm size range as the ones found on the cockpit panel of Figure 14. None of the objects that caused these 5 penetrations also penetrated the back plate.

Figure 28: Impact damage on front side engine cowling ring

Figure 29: Impact damage on rear side engine cowling ring

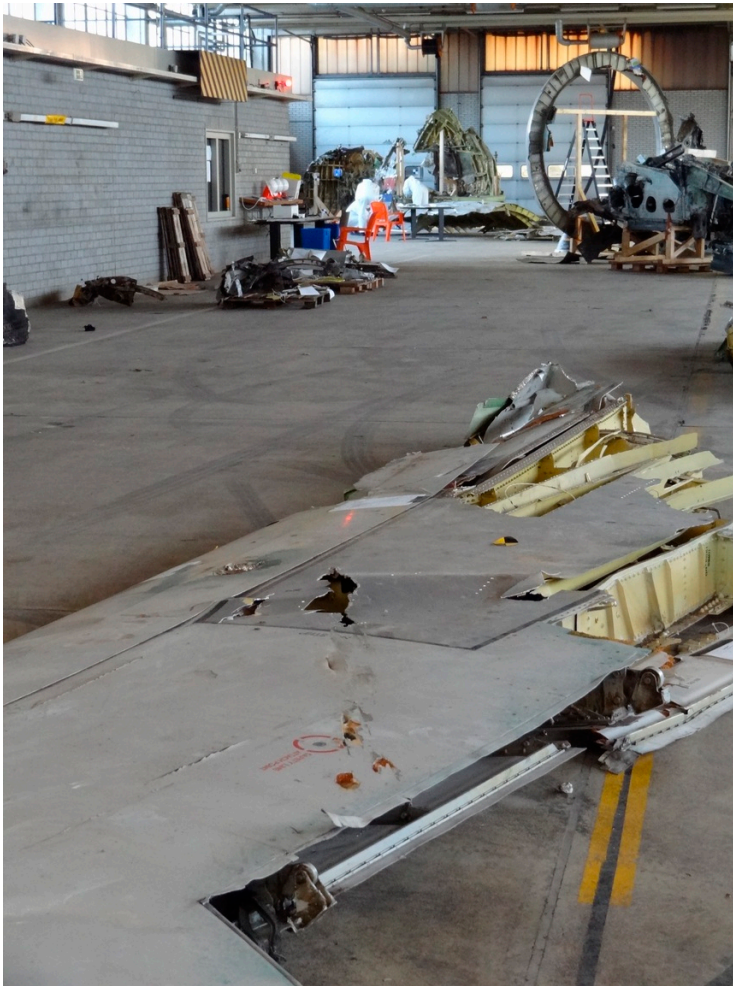
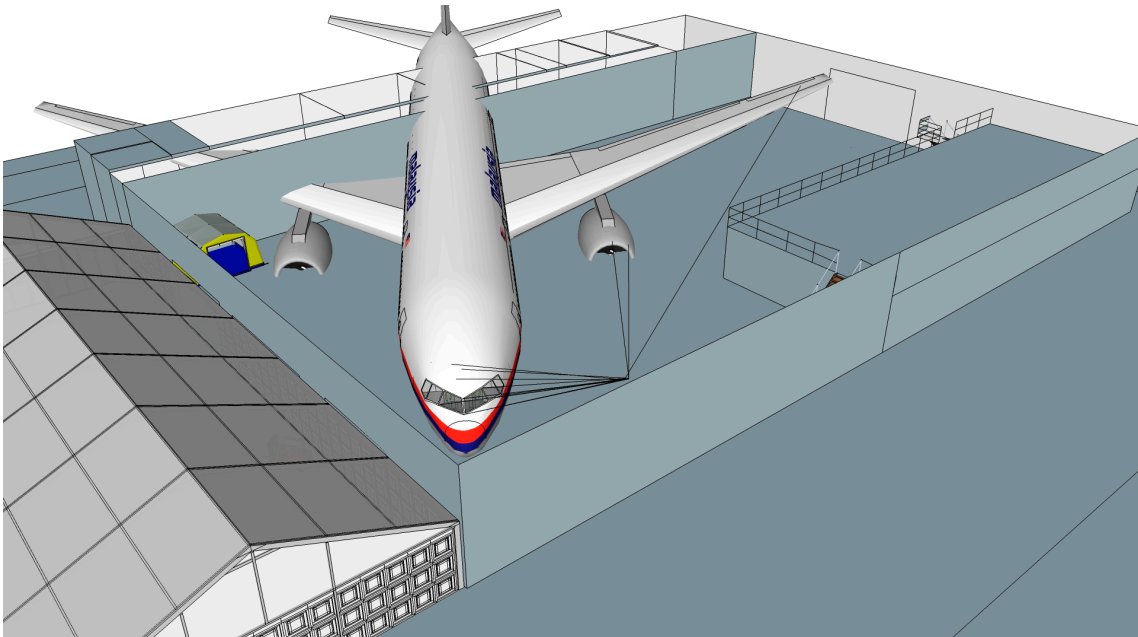
On the left-hand wingtip upper surface, damage is observed from the front to the rear. The direction to the damage origin is in the general direction to an area slightly to the left of the cockpit, (Figure 30). All damage directions lead to the same general area as indicated in Figure 31.

Figure 30: Damage to left wingtip

Figure 31: Overview of damage origin (not to scale) (Source: DSB)

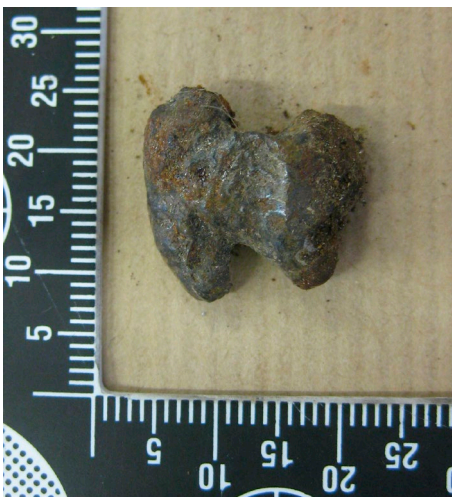
In the wreckage of the cockpit several non-aircraft fragments were found that are assessed to be the high-energy objects, or parts of the high-energy objects, which penetrated the aircraft from the outside. A number of these fragments have a distinct butterfly or bowtie shape, as the one seen in Figure 32.

Figure 32: Bowtie fragment found in the wreckage of the cockpit, size in mm (Source: DSB)

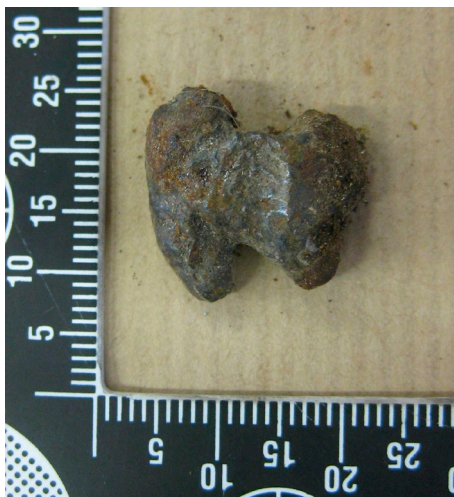
In the wreckage of flight MH17 several non-aircraft related, foreign fragments were found that are assessed to be the high-energy objects, or parts of the high-energy objects, that penetrated the aircraft from the outside. A number of these fragments found in the cockpit area have a distinct butterfly or bowtie shape, as the one seen in Figure 46. These fragments are recognized as one of the three types of preformed fragments used in the 9N314M warhead of the 9M38 and 9M38M1 missiles. Figure 47 shows these bowtie fragments in an inert 9N314M warhead. Accounting for deformation and abrasion due to explosion and impact, the bowtie fragments found in the wreckage of flight MH17 match the 9N314M warhead bowtie preformed fragments in shape, size and weight.

Figure 46: Bowtie fragment found in the wreckage of the cockpit, size in mm (Source: DSB)

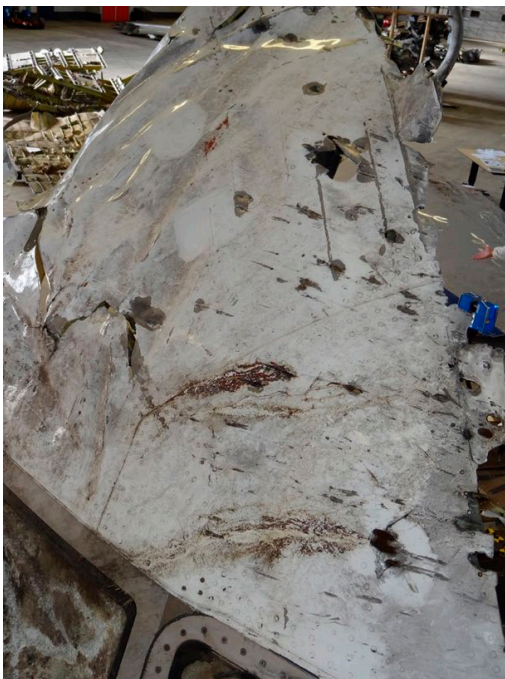
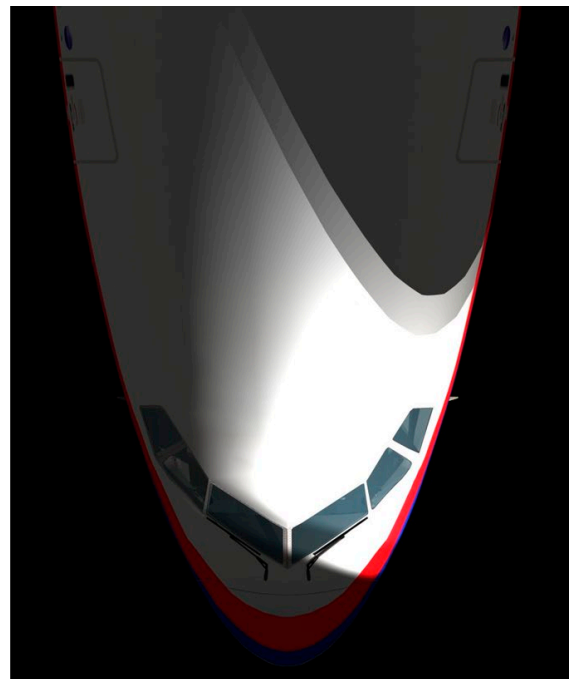
Figure 56: Matching of high-energy object impacts on cockpit roof

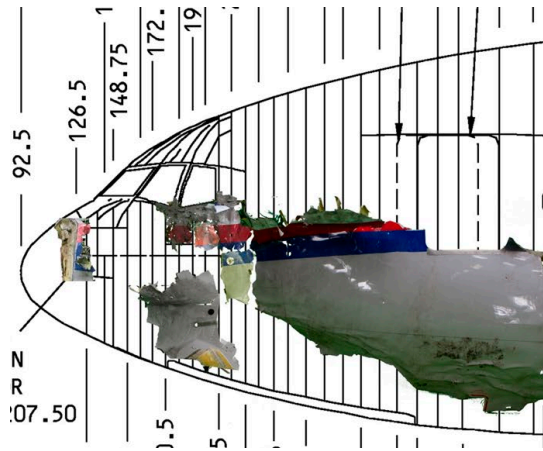
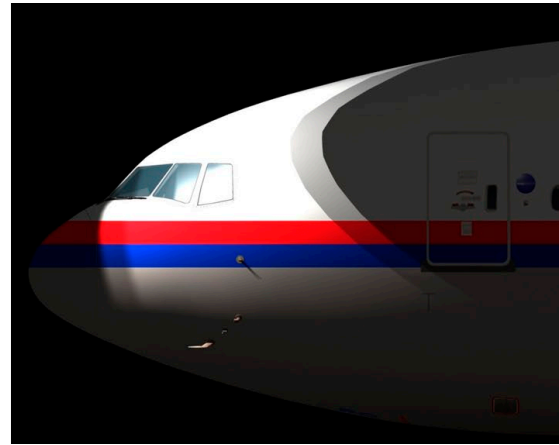
Figure 57: Matching of high-energy object impacts on cockpit left-hand side

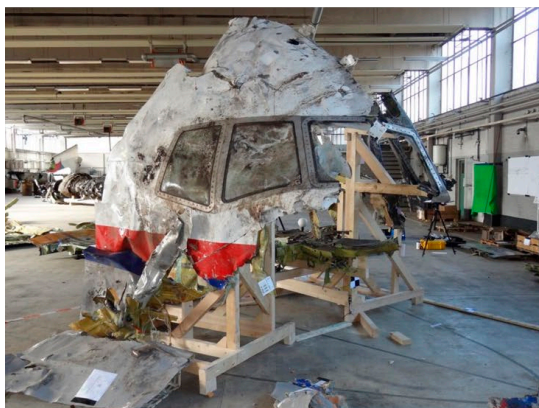
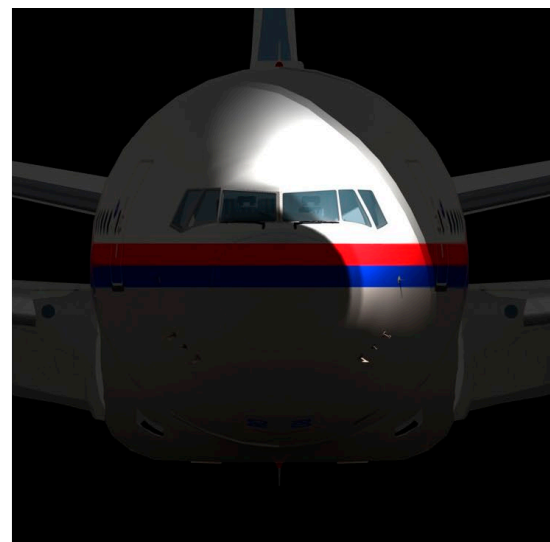
Figure 59: Matching of high-energy object impacts, front view
